PARTICLE TYPES AND SOURCES  
ASSOCIATED WITH LDEF\*

E. R. Crutcher and W. W. Wascher  
Boeing Defense and Space Group  
Seattle, WA 98124-2499  
Phone: 206/773-7002, Fax: 206/773-1473

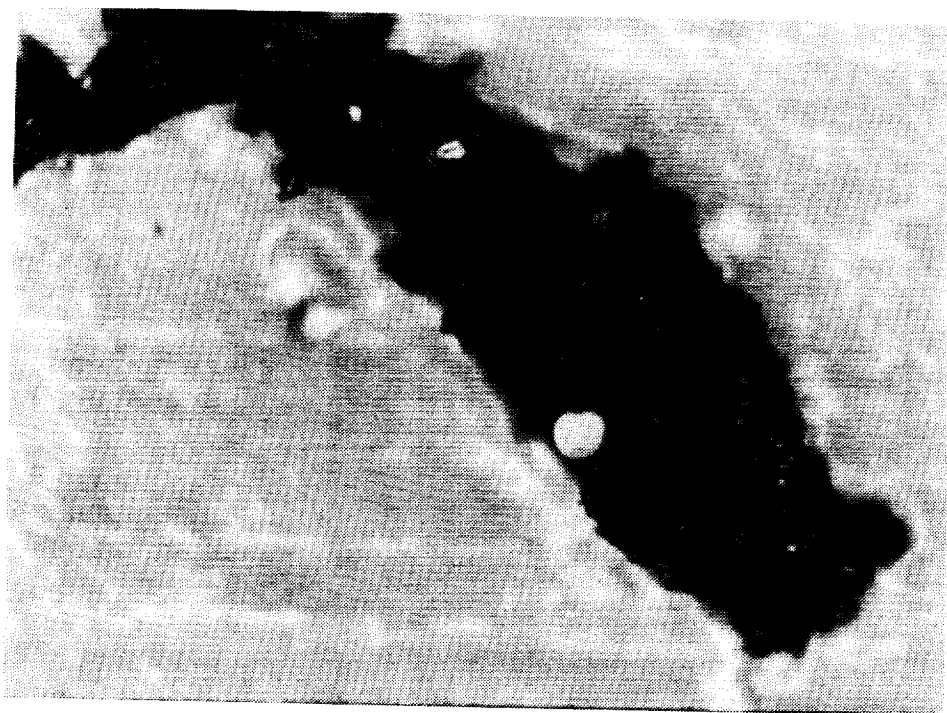
Photograph 17: Tapelift from kit 22, M0002 edge showing rubber wear with attached pine pollen and other debris. Rubber wear may be from the crane or from another tire source. 110x magnification.
